**VEHICLE CRASH TESTS OF THE
TYPE 80 BRIDGE RAIL**

1. REPORT NO. FHWA/CA/ESC-98/06 Part 3		2. GOVERNMENT ACCESSION NO.		3. RECIPIENT'S CATALOG NO.	
4. TITLE AND SUBTITLE VEHICLE CRASH TESTS OF THE TYPE 80 BRIDGE RAIL				5. REPORT DATE March 1999

16. ABSTRACT An aesthetic, see-through concrete bridge rail, Type 80, was built and tested in accordance with NCHRP Report 350. The Type 80 bridge rail is an 810 mm-tall, reinforced concrete barrier. The rail has 280 mm-high by 1620 mm-long gaps, 230 mm above the bridge deck surface. The barrier tested was 23 m-long and was constructed at the Caltrans Dynamic Test Facility in West Sacramento, California. A total of three crash tests were conducted under Report 350 test Level 4, one with a 820 kg car, one with a 2000 kg pickup truck and one with an 8000 kg single unit van truck. The results of all three tests were within the limits of the Report 350 guidelines. The Type 80 bridge rail is recommended for approval on California highways requiring TL-4 bridge rails.

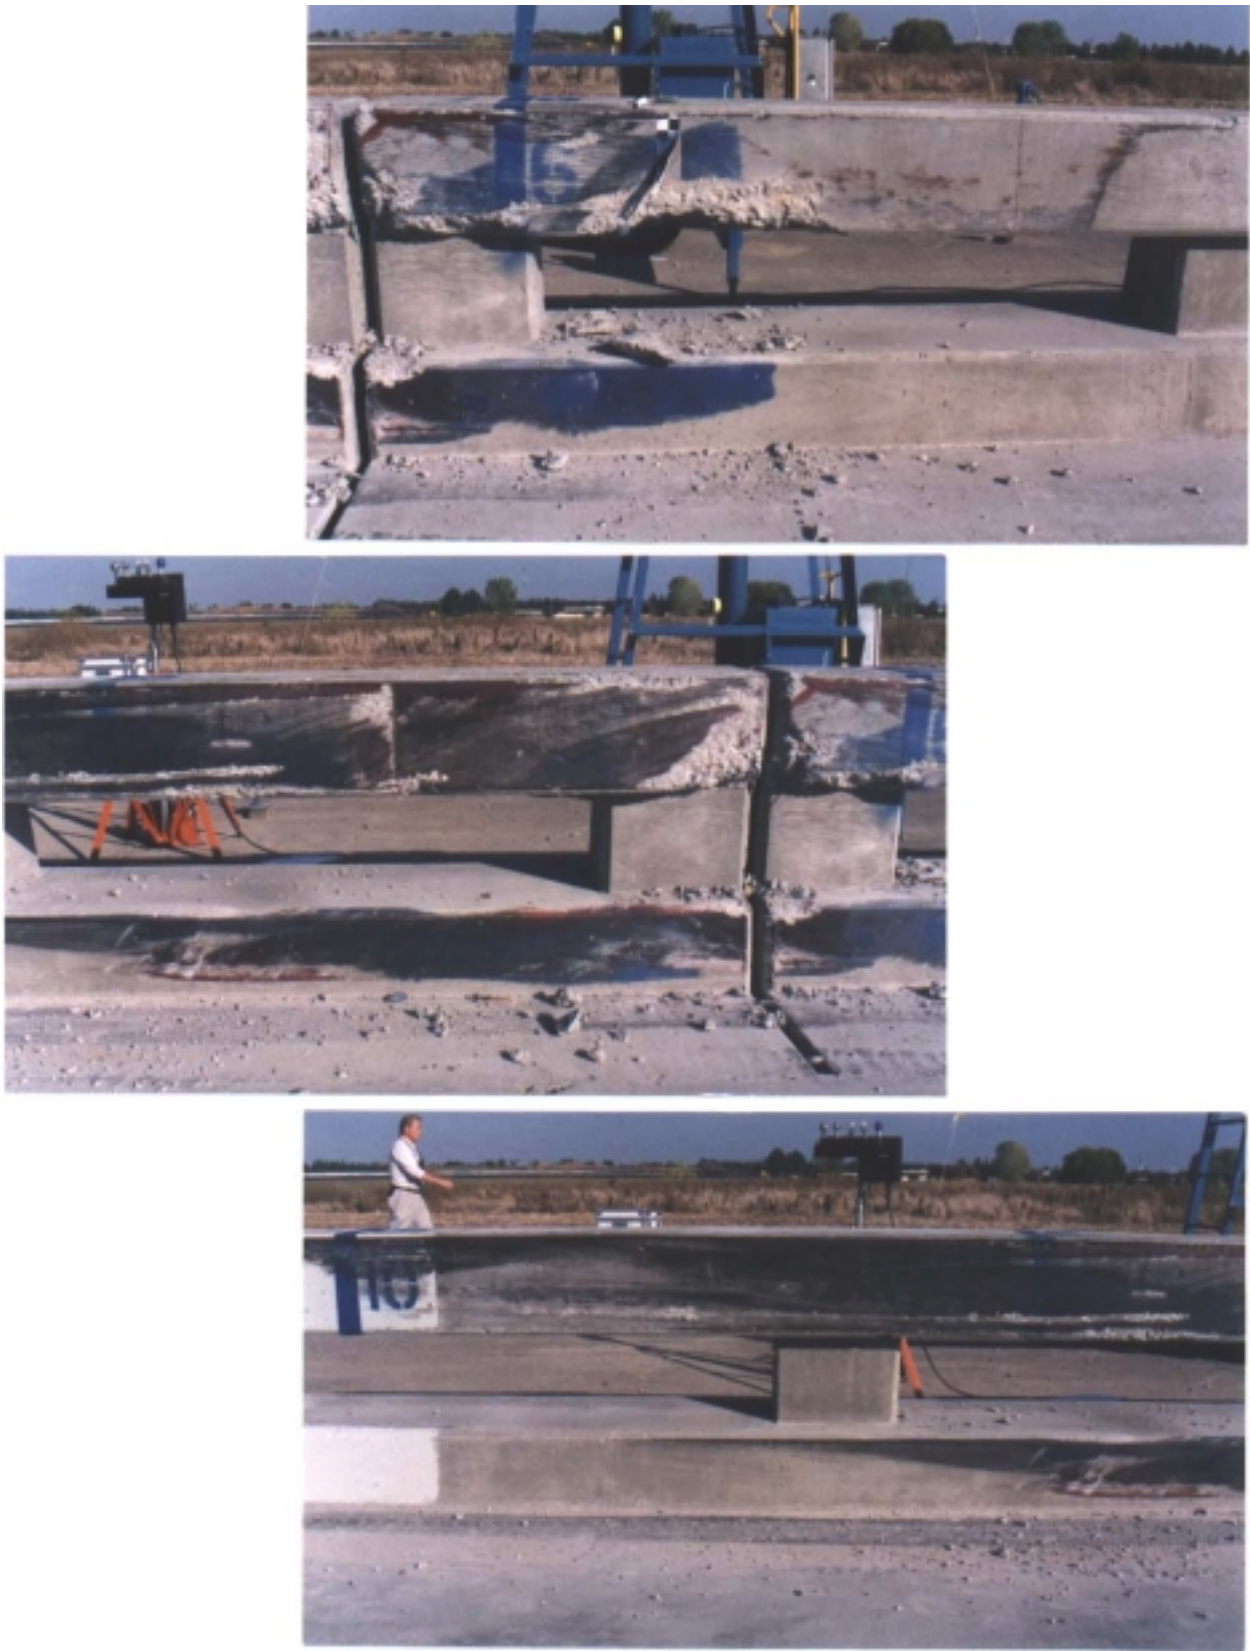
Figure 2-42 Close up of Impact Area

Barrier Damage: The barrier sustained minor spalling near the point of impact and at the expansion joint. Other barrier damage was cosmetic, consisting of scrapes and tire marks, with no structural damage.

The bridge rail was scraped along the curb and beam section face leaving exposed patches of aggregate and concrete spalls. Most of the spalling occurred 0.75 m upstream of the expansion joint and at the expansion joint, Figure 2-42. The spalls were minor in nature and could be easily repaired. Additional marks were left on the bridge rail from the trucks tires. The right front and rear tires were painted blue and red, respectively.
